**HARDLOCK**®

APPLICATIONS

HARDLOCK Nut (HLN)

The Globally Recognized HARDLOCK Nut

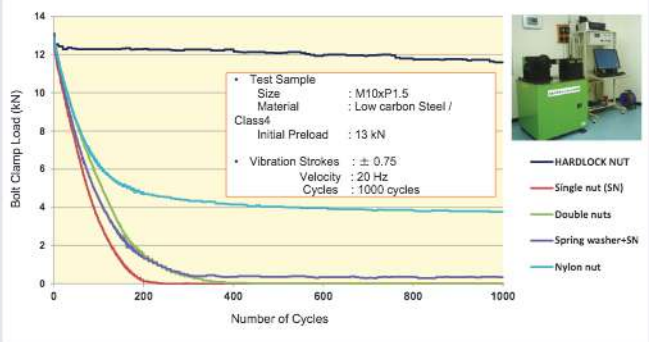
Junker Test

Impact Vibration Test Complying to NAS 3350/3354

TEST SAMPLE CONDITIONS

Size M12x1.75
Material SS400
Finish Trivalent Chromate
Torque 40 Nm

Vibration frequency 1,780c.p.m
Vibration stroke 11mm
Impact stroke 19mm
Accelerated vibration 19.5Ga

No loosening
Test aborted
Vibration Time
1020 sec (17 min)

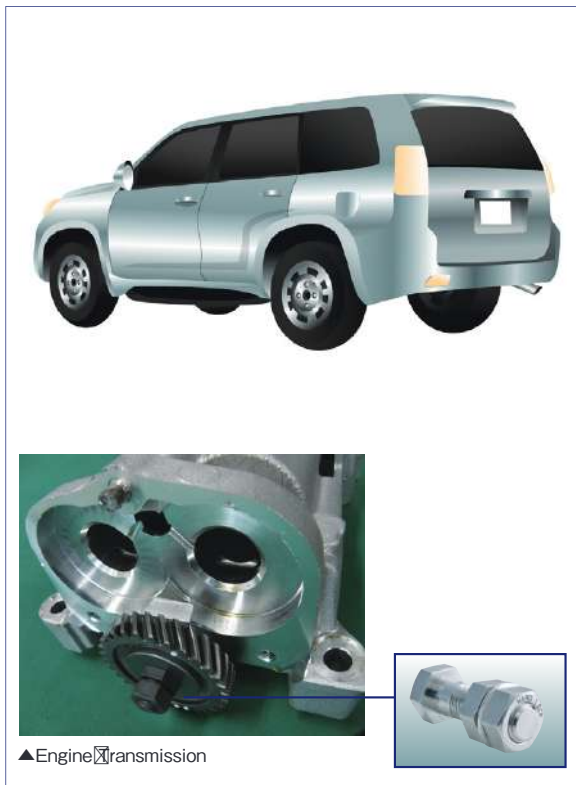
HLN SUV Engine transmission

Before

- Flanged Nuts were utilized in the engine transmissions of SUVs
- Loosening of nuts occurred frequently when starting the engine and many SUVs had to be recalled.

- By switching from flanged nuts to HARDLOCK Nuts the loosening problem was resolved.
- By utilizing HARDLOCK Nut the loosening occurring when starting the engine were also resolved.

Major Loosening Cause

- Loosening due to cyclic stress in the rotational direction of the bolts axis

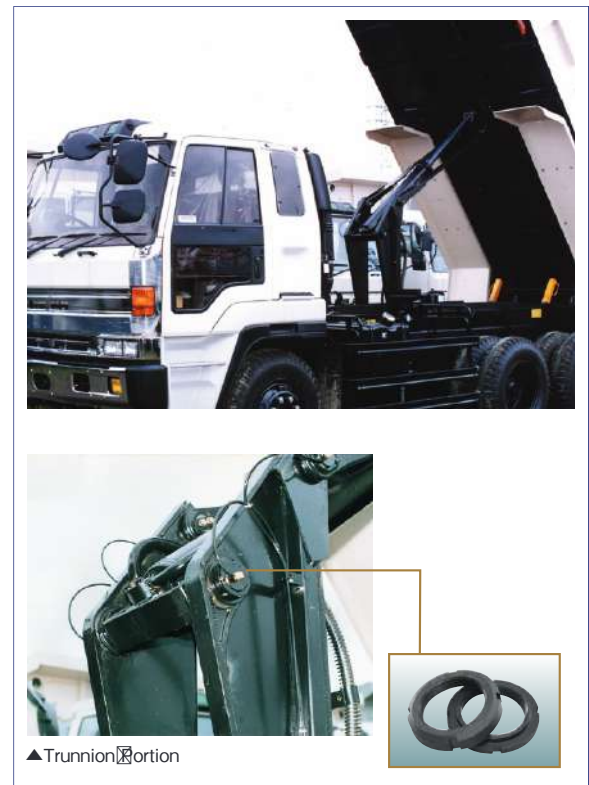
HLB Specially equipped vehicle trunnion fixing

Before

- Double bearing nuts were used as countermeasure for loosening
- The double bearing nuts were tightened by the "double nut method". However, loosening occurred due to the variation in tightening force.

- By adopting the HARDLOCK Bearing Nut, the workability was improved and the loosening problem was solved.
- By switching to HARDLOCK Nut, the maintenance costs were significantly reduced.

Major Loosening Cause

- Loosening due to cyclic stress in the rotational direction of the bolt axis

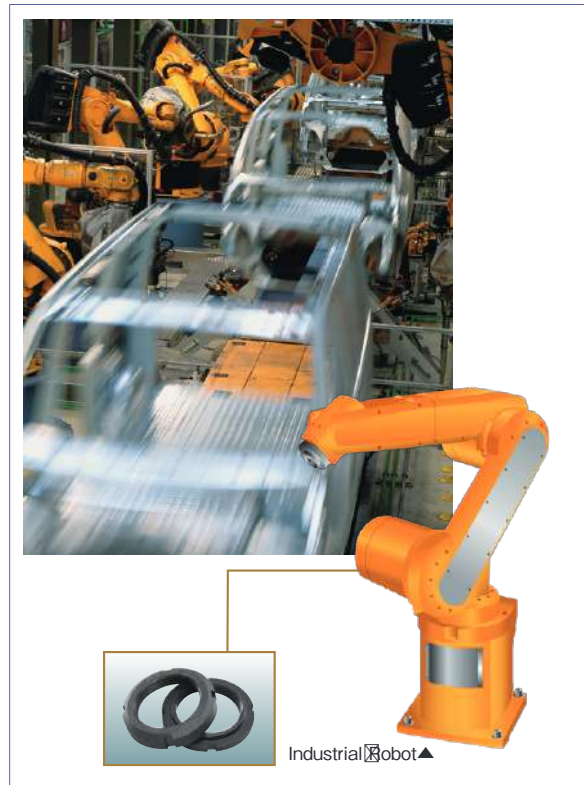
Industrial Robot ▲

- Revolving torque type self-locking nuts where used were in the arm portion, but iron powder produced by the friction between the nut and shaft caused poor movability.
- Torque control was difficult with revolving torque type self-locking nuts and there was a problem with variety of axial force.

- By switching to HARDLOCK Bearing Nut the problem with shaft damage was resolved.
- Axial force management by proper torque combined with elimination of loosening improved the product performance of the industrial robots.

Major Loosening Cause

- Loosening due to cyclic stress in the rotational direction of the bolt axis

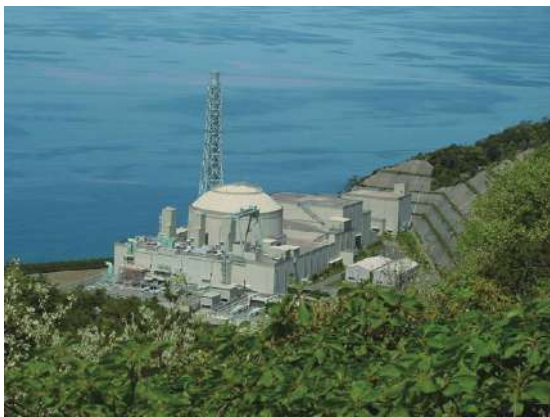
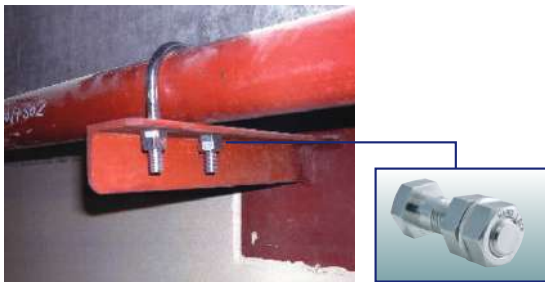
HLN Nuclear Power Plant Reactor Core

▼ Piping Support

Before

- Double nuts were used in the fixed stand of the reactor core and piping supports in the power plant. Retightening work and maintenance were required on a daily basis due to frequent loosening.
- Since nuclear power plants are large in size and places where nuts are used are plenty, huge amounts of maintenance cost and maintenance time was necessary.

- HARDLOCK Nut demonstrated superior self-locking performance and prevention of loosening.
- Safety in the nuclear power plant facilities increased, time spent on maintenance and maintenance cost was reduced immensely.

Major Loosening Causes

- Loosening due to micro-motion abrasion
- Loosening due to thermal causes

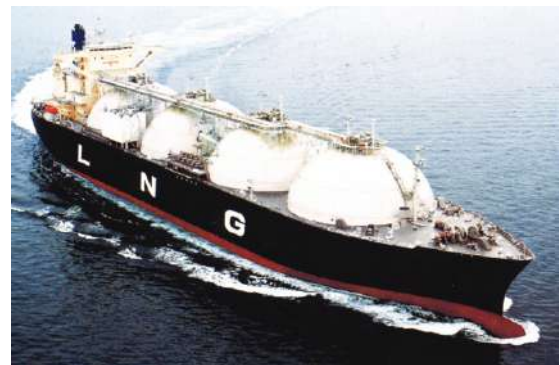
HLN Ship Internal Combustion Engine

▼ Ship Engine

Before

- Double nuts were used on the internal combustion engines of the ship, loosening due to thermal expansion and severe vibration occurred on a daily basis.
- Retightening work had to be made frequently and an enormous amount of time and cost was spent on maintenance.

- Switching to HARDLOCK Nut with special coating, loosening due to vibration and/or thermal expansion was eliminated.
- Significant reduction in maintenance cost as well as retightening work.

Major Loosening Causes

- Loosening due to micro-motion abrasion
- Loosening due to cyclic stress in the direction perpendicular to the bolt axis
- Loosening due to thermal expansion

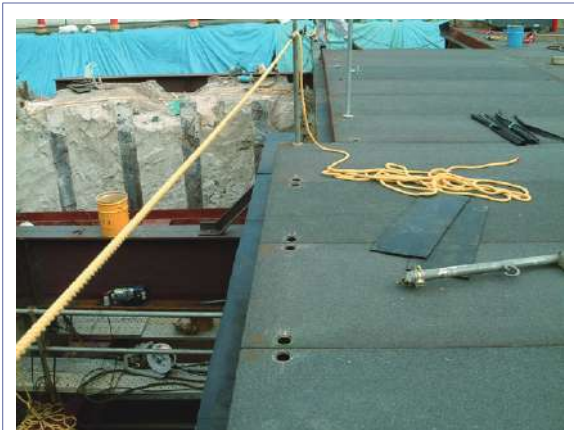
▲ Road Plates

- Countermeasures such as welding and insertion of cushioning materials to reduce vibration in the road plates were carried out. However, due to poor welding and replacement of cushioning material work, both options were unsatisfactory.
- Another serious problem was the noise control due to collision of the road plates when vehicles passed over them.

- By switching to HARDLOCK Nut in the connection portion of the road plates, problems such as loosening were eliminated.
- Additionally, the noise generated when vehicles pass over the road plates was eliminated and overall costs were reduced.

Major Loosening Cause

- Loosening due to cyclic stress in the direction perpendicular to the bolt axis

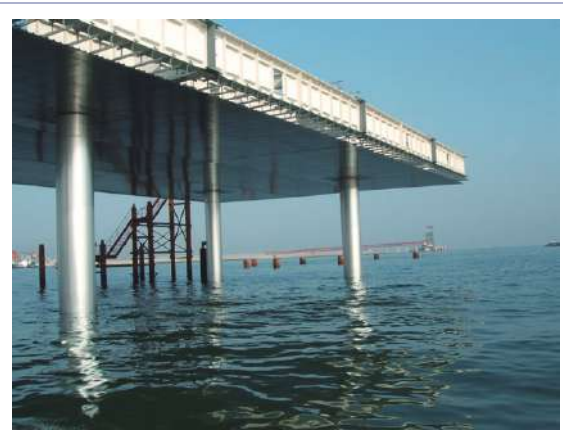
◀ Pier Over Plate Mounting

- During the construction of the titanium panel on artificial grounds near surface of the offshore airport, prevailing torque self-locking nuts were studied.
- Since the prevailing torque type self-locking nuts caused scratches on the bolt (peeling off the plating), rust occurrence was a serious problem and concerns regarding safety and corrosion resistance arose.

- By switching from prevailing torque type self-locking nuts to HARDLOCK Nuts, problems related to bolt damage and corrosion were eliminated.
- Loosening due to severe vibration in the pier over plates during landing and take-off of aircrafts were eliminated. HARDLOCK Nut also corresponded to the 100-year warranty requested by the Ministry of Land, Infrastructure and Transport.

- Loosening due to micro-motion abrasion
- Loosening due to cyclic stress in the direction of the bolt axis

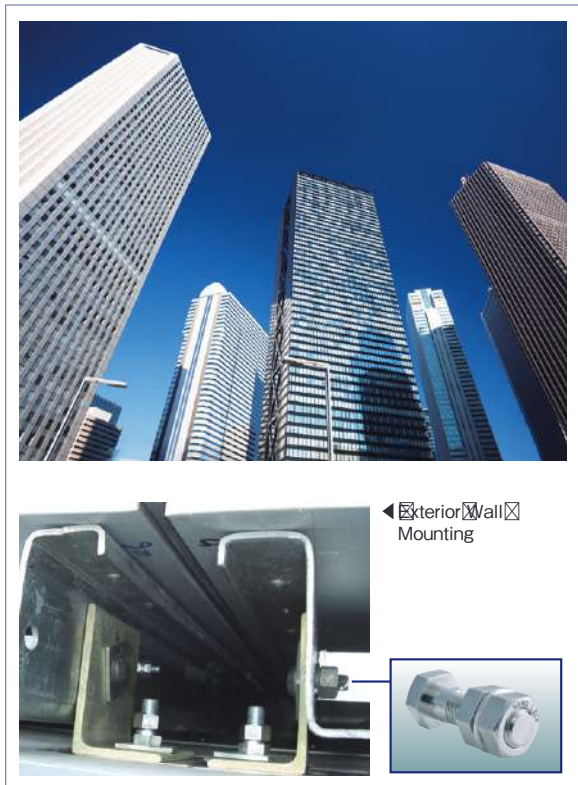
HLN Exterior Wall of High-rise Buildings

Exterior Wall Mounting

- Aluminum curtain walls were mounted on the exterior walls of high-rise buildings with metallic fastener, but due to the high torque required to tighten the metallic fasteners, it caused expansion of the aluminum which would cause a specific sound.

Major Loosening Causes

- Loosening due to cyclic stress in the direction perpendicular to the bolts axis
- Loosening due to thermal causes

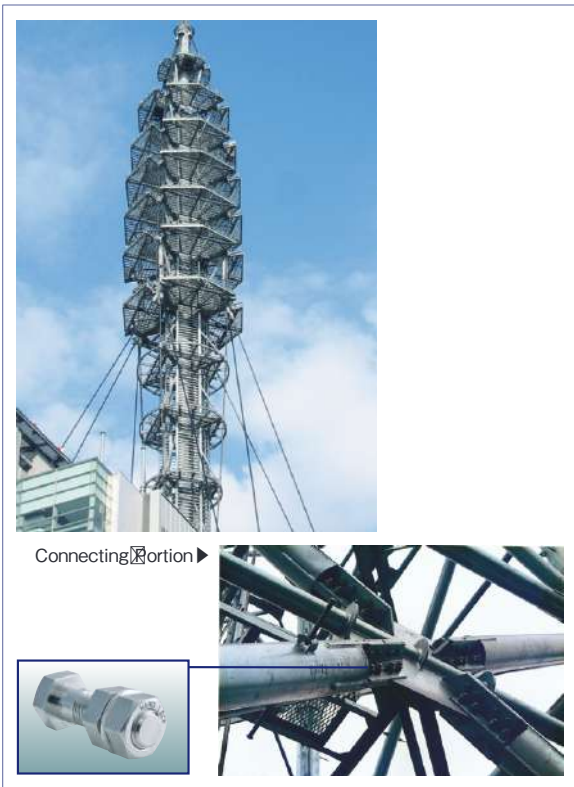
HLN Communication Towers

Before

- Other self-locking double nuts were used in the connection portion in communication towers. However, due to loads generated by wind and vibration that occurs on a daily basis, the axial force was lowered and loosening occurred.
- Re-tightening work from maintenance personnel and routine maintenance cost was required to be reduced.

Major Loosening Causes

- Loosening due to cyclic stress in the direction perpendicular to the bolt axis
- Loosening due to cyclic stress in the rotational direction of the bolt axis
- Loosening due to excessive external force

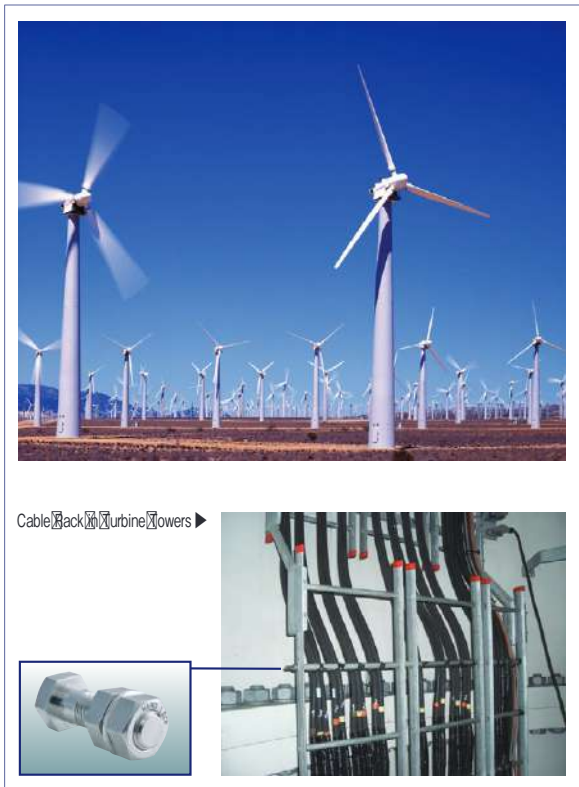
HLN Transmission Equipment in Wind Turbine Towers

Before

- Wind turbine towers are installed in areas where there are strong winds. Due to the regular stress induced by strong winds, common double nuts and/or spring washers were not able to produce significant locking effect and eliminate loosening.
- Nylon nuts were used in the fastening portions of wiring cable racks, ladders etc. inside of wind turbine towers. However, due to the vibration caused by the rotation of the blades (wings) the nylon nuts became loose on a regular basis.

- By switching to HARDLOCK Nut, due to successful axial force control and proper torque, loosening was eliminated.
- Regular maintenance work and equipment maintenance cost was significantly reduced.

Major Loosening Causes

- Loosening due to cyclic stress in the direction perpendicular to the bolt axis
- Loosening due to micro-motion abrasion

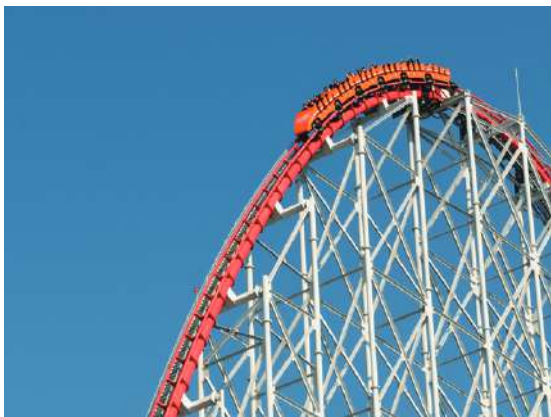
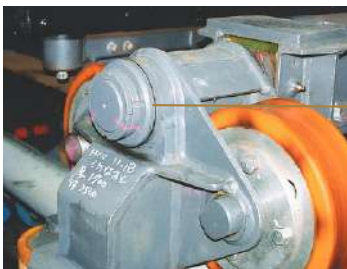
▲ Guide Roller Portion

Major Loosening Causes

- Loosening due to cyclic stress in the rotational direction of the bolt axis
- Loosening due to cyclic stress in the direction of the bolt axis

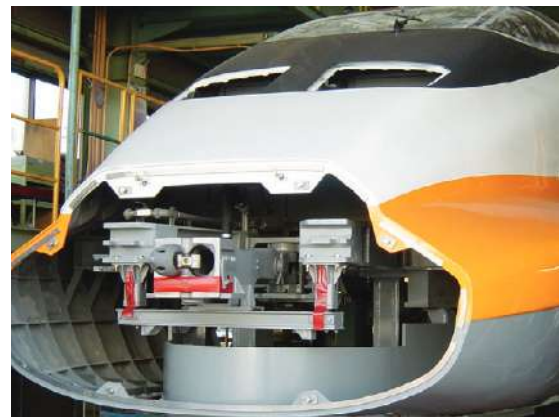
▼ Shinkansen Tight Coupler

- High speed rail cars, repeated impact of the rail coupling causes the nut to loosen and may even risk detachment. Damage to friction ring also causes the nut to loosen.

- By using the HARDLOCK Nut, even under repeated impact, loosening is prevented and detachment does not occur. Breakage of the friction ring is eliminated by using the HARDLOCK Nut and has been adopted by many rail car manufacturers.

Major Loosening Causes

- Loosening due to cyclic stress in the direction of the bolt axis
- Loosening due to cyclic stress in the direction perpendicular of the bolt axis

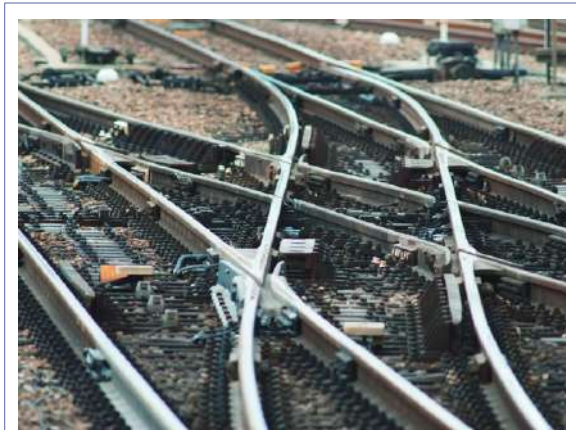
▲Railroad Switch

- When train passes, force of 500G is applied to the switch, and even specially shaped double nuts used on the movable parts can become loose on a daily basis.
- While the switch movable part is essential to maintain the track gauge, it is extremely difficult to maintain the gauge of the track while preventing loosening.

- By using the HARDLOCK Nut, the maintenance cost associated with inspection and re-tightening was successfully reduced.
- The HARDLOCK Nut successfully maintained the gauge of the track and prevents loosening simultaneously. As a result, the HARDLOCK Nut has been adopted by all railway companies in Japan.

Major Loosening Causes

- Loosening due to cyclic stress in the direction of the bolt axis
- Loosening due to cyclic stress in the direction perpendicular of the bolt axis

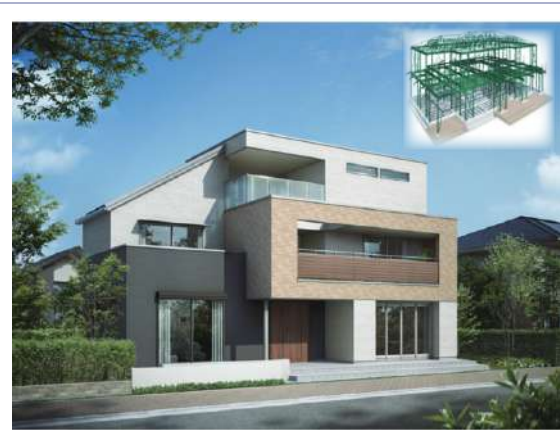
▲Steel Frame Joint

- Conventionally, based on the Building Standards Law, single nuts and spring washers was going to be used in the light-gauge steel joint as a countermeasure for loosening.

Major Loosening Causes

- Loosening due to cyclic stress in the direction of the bolt axis
- Loosening due to cyclic stress in the direction perpendicular of the bolt axis

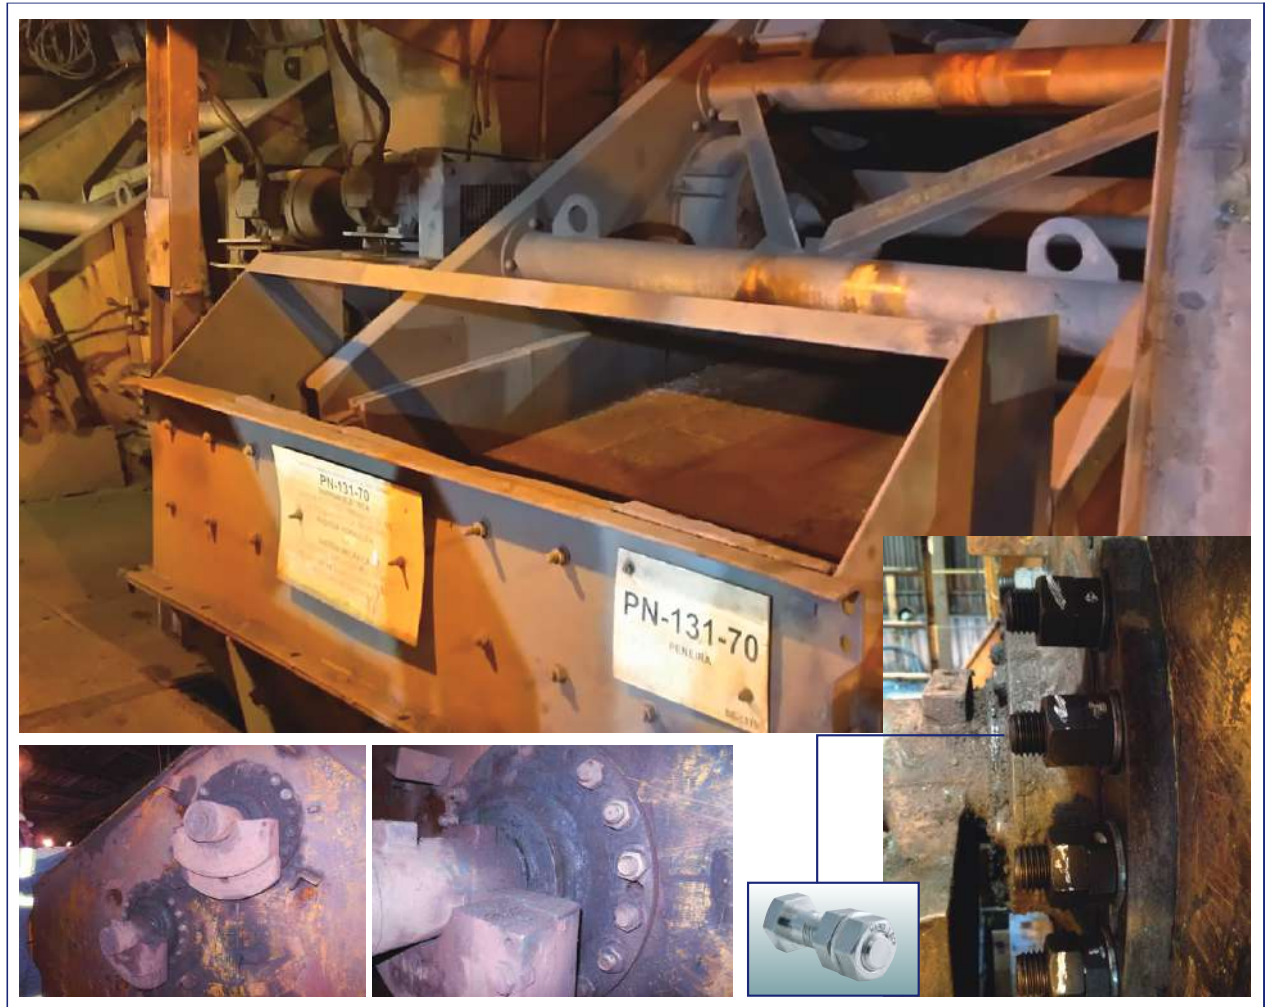
Pendulum Fastening for Vibration Screens

Before

Major Loosening Cause

- Loosening due to cyclic stress in the direction perpendicular of the bolts axis
